Expert Tips

Fire-Resistive Detailing for Corridor Walls and Ceilings

Discusses requirements for construction and the continuity of wall-to-ceiling intersections, and options for thinner solid sawn structure depths.

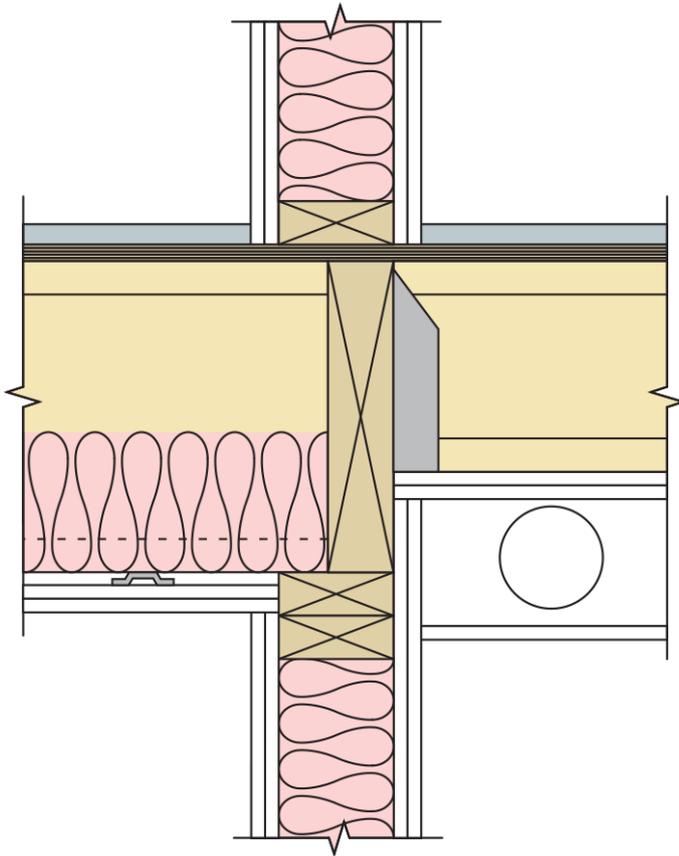
In order to address this unique condition, several methods exist to detail the top of corridor wall condition. The first option would be to extend the corridor wall membranes on each side of the wall to the underside of their respective rated floor/ceiling assembly. Due to the typical thinner floor structure in the corridor, this would result in the membrane on the corridor side of the wall extending higher than the gypsum on the non-corridor side of the corridor wall as shown below.

As this section notes, the corridor wall (fire partition) is only required to extend to the underside of the rated floor/ceiling assembly above. The unique scenario that often exists in light wood-frame multi-family construction is that the depth of the floor structure in the dwelling unit exceeds the depth of the floor structure in the corridor due to differences in floor spans and size of MEP elements to be accommodated.

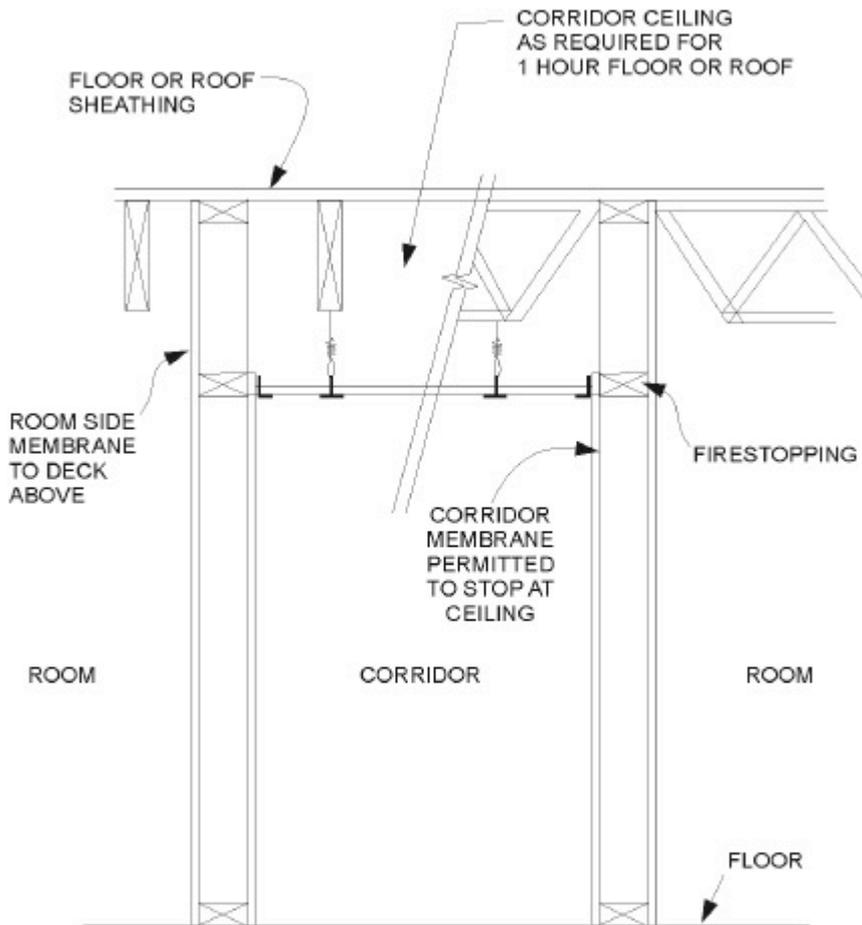
**Figure 708.4(2)(B)
FIRE PARTITION CONTINUITY**

Exception 2 allows for only one side (the room side) of a fire-resistance-rated wall assembly to be continuous to the rated assembly above. The membrane on the corridor side of the wall is carried up to the underside of the corridor ceilings, provided the corridor ceiling is constructed of materials that have been tested as part of a 1-hour

The image below from IBC Code Commentary Figure 708.4(2)(B) illustrates this exception option.

Other options for detailing this condition are given as exceptions to IBC 708.4. Exception 2 outlines a similar option but could also be seen to expand options for the ceiling including suspended ceilings, commonly used in corridors.

Where the room-side fire-resistance-rated membrane of the corridor is carried through to the underside of the floor or roof sheathing, deck or slab of a fire-resistance-rated floor or roof above, the ceiling of the corridor shall be permitted to be protected by the use of ceiling materials as required for a 1-hour fire-resistance-rated floor or roof system.

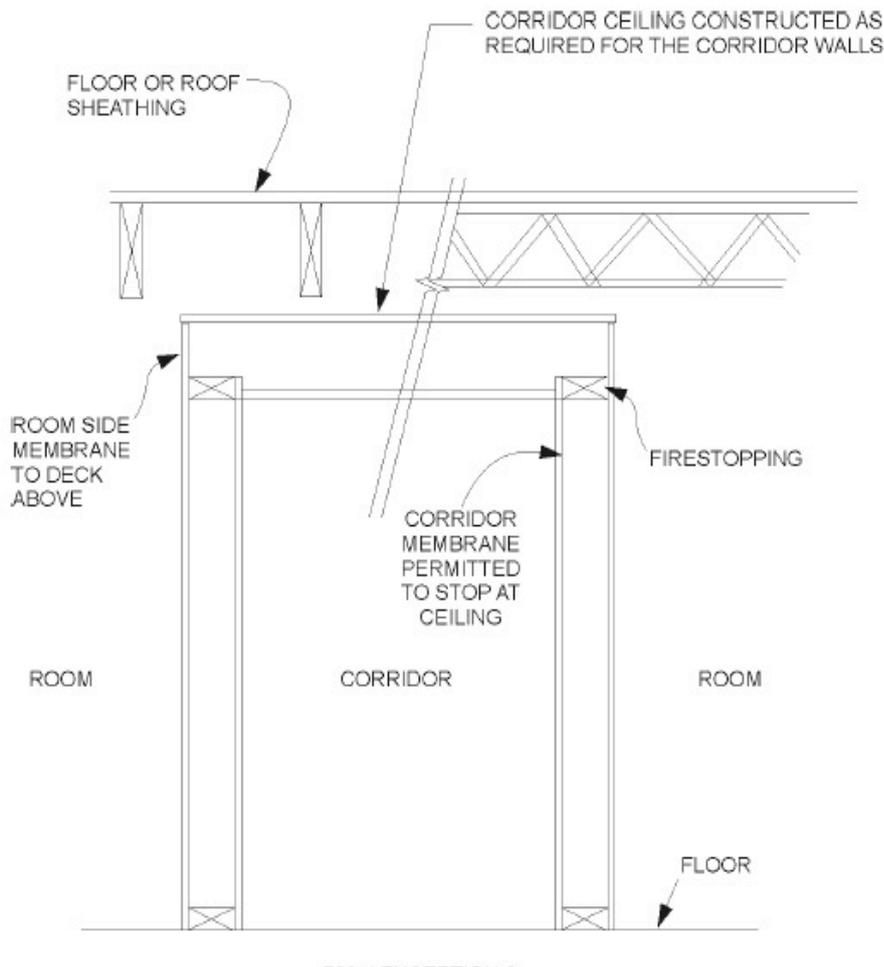
Figure 708.4(2)(C)
FIRE PARTITION CONTINUITY

Exception 3 allows the use of a framed ceiling within the corridor that matches the construction of the corridor wall assembly, essentially making a three-sided box in the corridor of identical construction details. This framed ceiling could be the actual floor structure of the corridor or could be a sub-framed ceiling with the actual floor structure above.

The image below from IBC Code Commentary Figure 708.4(2)(C) illustrates this exception option.

Where the corridor ceiling is constructed as required for the corridor walls, the walls shall be permitted to terminate at the upper membrane of such ceiling assembly.

Exception 3 allows for a corridor to be constructed in a “tunnel” fashion—with rated walls and a rated top. In these cases, the walls are not required to extend to the underside of a rated assembly. This is a unique provision in the code and the fact that it permits a wall assembly to be turned into a horizontal position should not be applied to other sections of
